# Brightpack ClipBox System Test Report

The Brightpack ClipBoxes were tested with a load of 3,780lbs. The tests accomplished on the test units were the stacking, vibration, drop, incline impact, forklift handling, and disassembly tests. The boxes passed all requirements with no significant problems encountered.

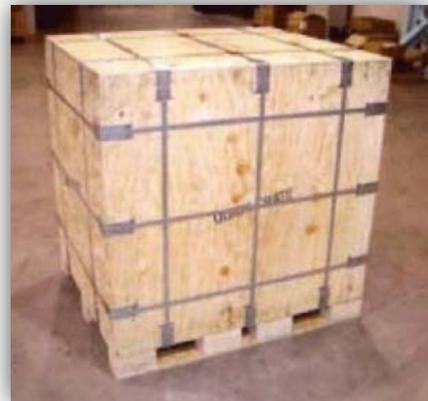
### Box

External Dimensions (length\*width\*height mm): 1200x1000x1118

Internal Dimensions (length\*width\*height mm): 1170x970x973

Material: OSB in 15mm

Steel clips: 28

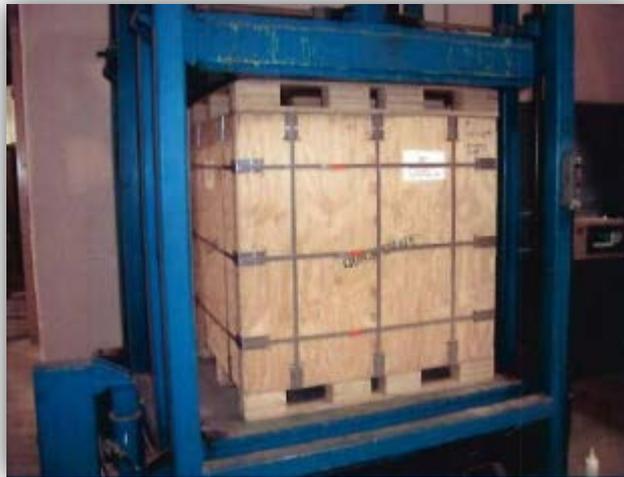
The test unit was compressed with a load force of 12,165 pounds for 60 minutes. No damage was noted as a result of this test. See Photo 1 of the test unit in the compression unit.

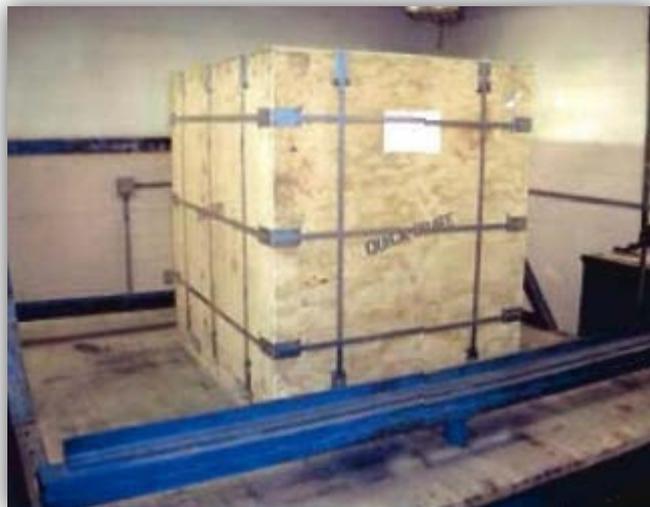
The test unit was vibrated 90 minutes at 200 RPM in the longitudinal orientation and 90 minutes at 200 RPM in the lateral orientation. No damage was noted as a result of this test. Photo 2 shows the test unit on the vibration platform.

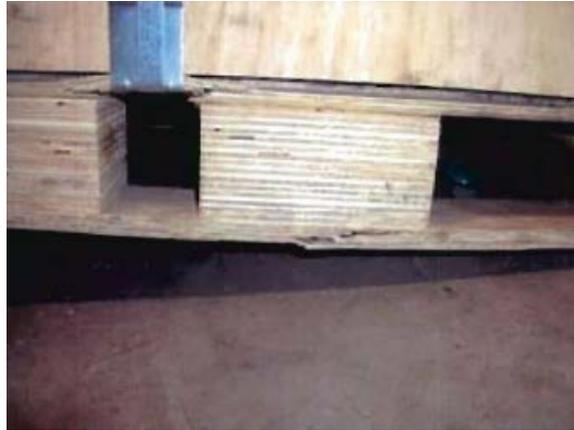
The test unit was edgewise rotationally dropped from a height of 12 inches on both longitudinal sides and both lateral sides. No significant damage was noted as a result of this test; however, the test unit sustained minor

damage to the bottom skids and the top deck during drop testing. The damage was deemed minor because it would not interfere with the container safely continuing on with its intended mission. The minor damage that occurred is common to this type of container with the 4,000-lb. load capacity. Photo 5 shows the test unit during the edgewise drop test. Photo 4 shows the minor damage sustained during the drop tests.

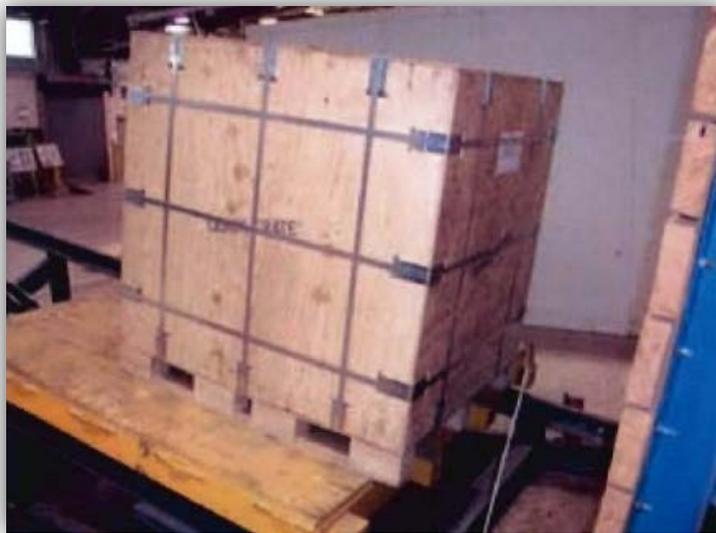
The test unit was impact tested on both longitudinal sides and both lateral sides. No significant damage was noted as a result of this test. See Photo 6 for the specimen during the lateral incline-impact test.

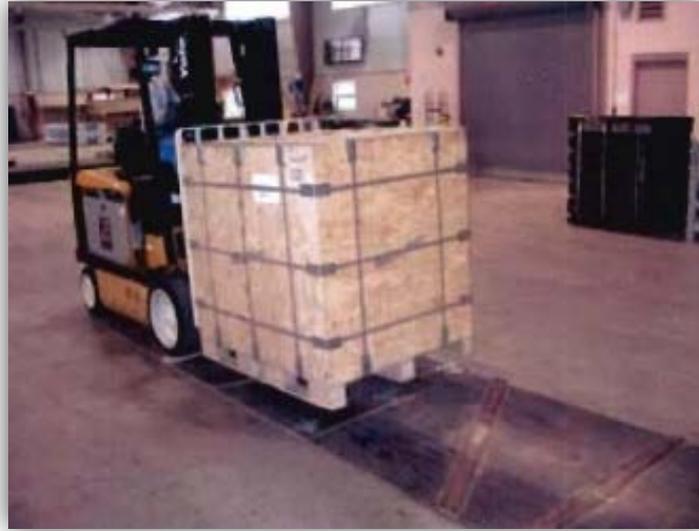
The test unit was lifted clear of the ground by a forklift from both longitudinal sides and both lateral sides and transported on the forks. Photo 7 shows the test unit during the Forklifting Test. No damage was noted as a result of this test.
